## Situation Photo Log

Monday, June 18, 2012 Kalamazoo River / Enbridge Spill

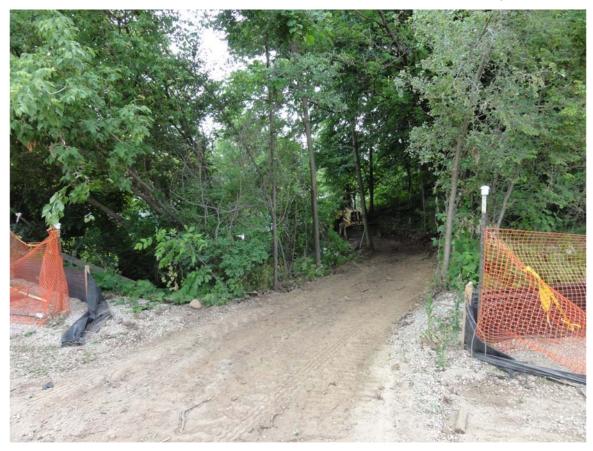
1. Ceresco Dam upstream portage observed being constructed.

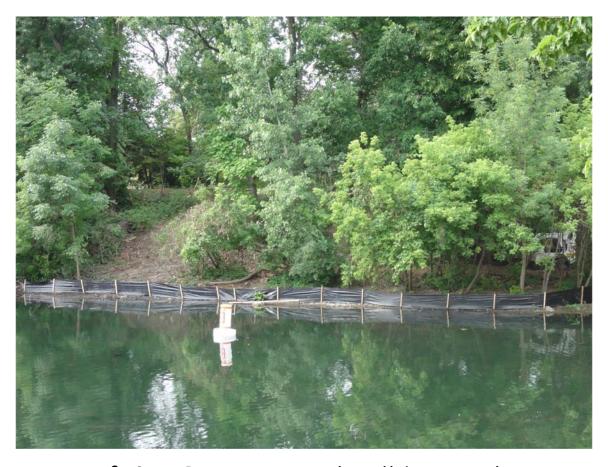
2. Ceresco Dam upstream portage observed being constructed.

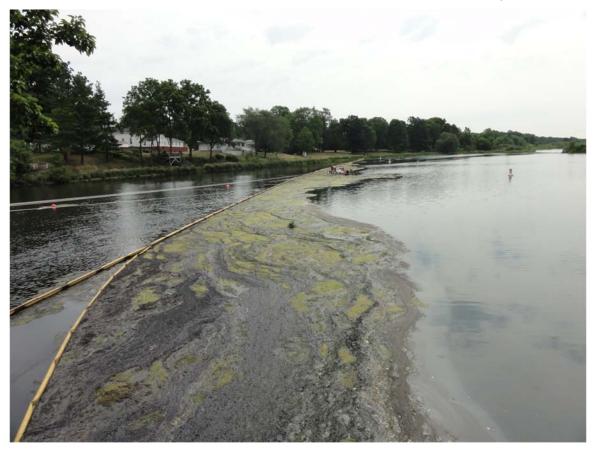
3. Ceresco Dam boom, observed crews removing debris.

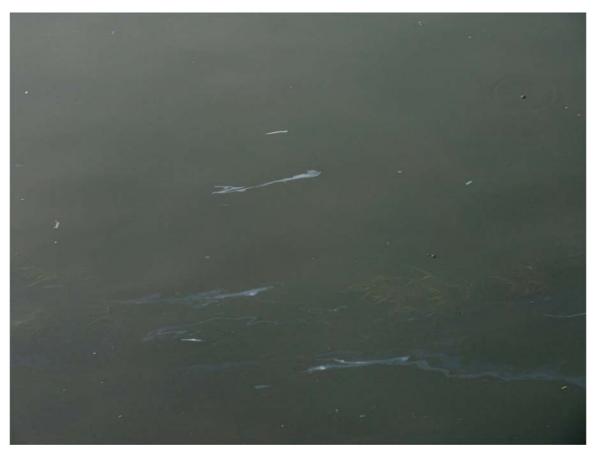
4. Ceresco Dam sheen observed.

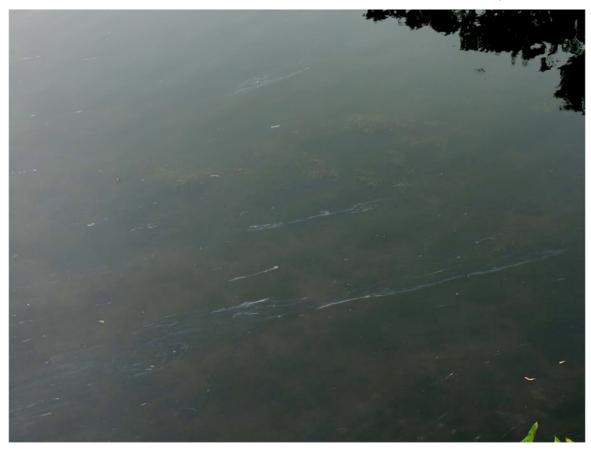
5. Ceresco Dam sheen observed.

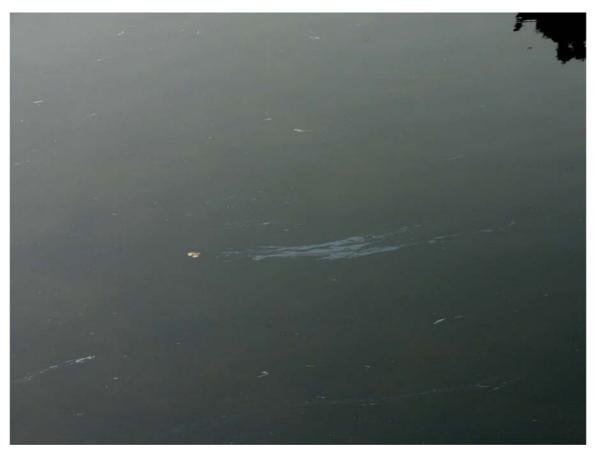
6. Ceresco Dam sheen observed.

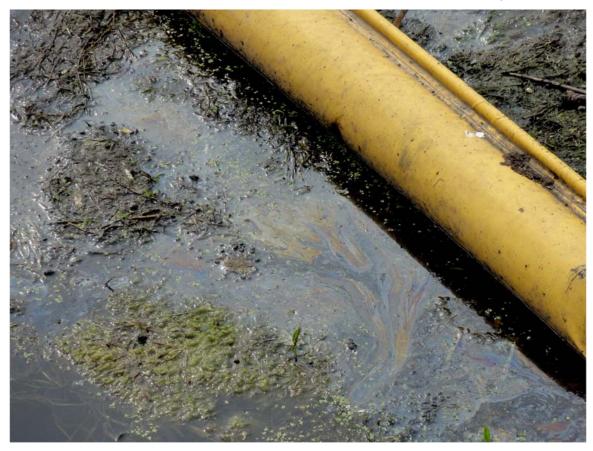
7. Ceresco Dam rainbow sheen observed on downstream side of boom.

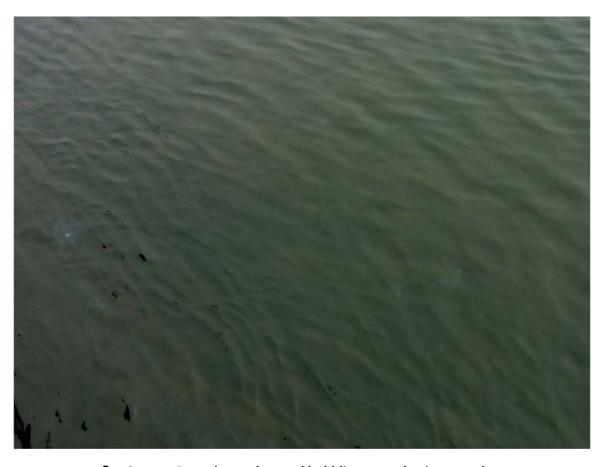
8. Ceresco Dam sheen observed bubbling up and going over dam.

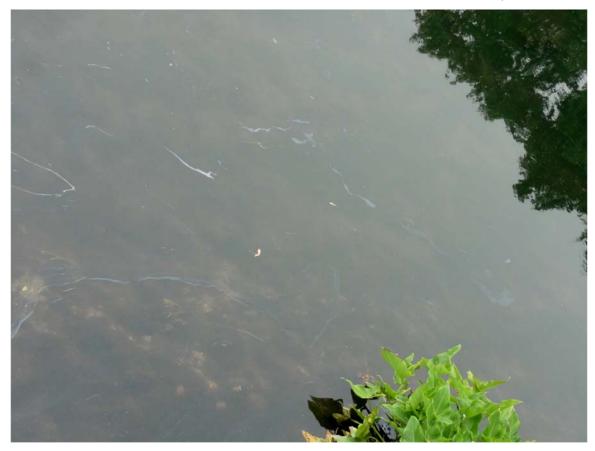
9. Ceresco Dam sheen observed.

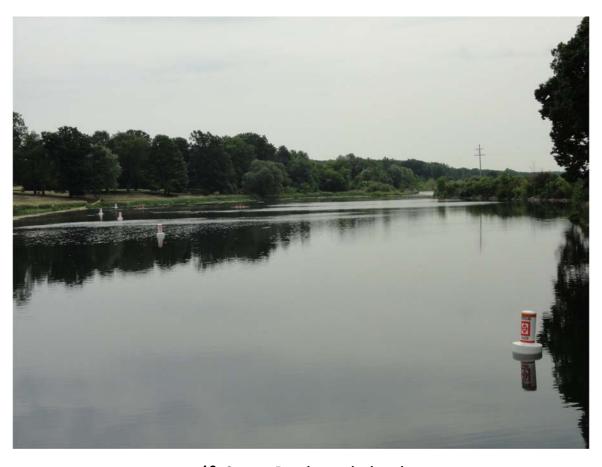
10. Ceresco Dam buoys deployed.

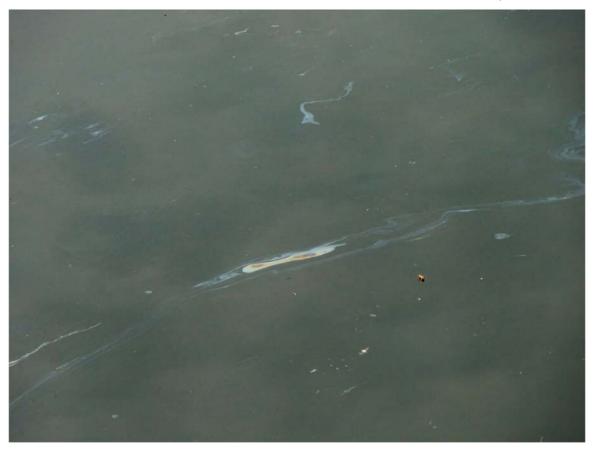
11. Ceresco Dam sheen observed.

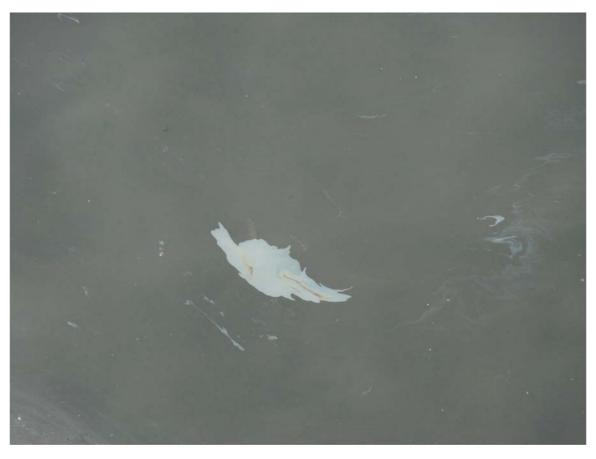
12. Ceresco Dam sheen observed.

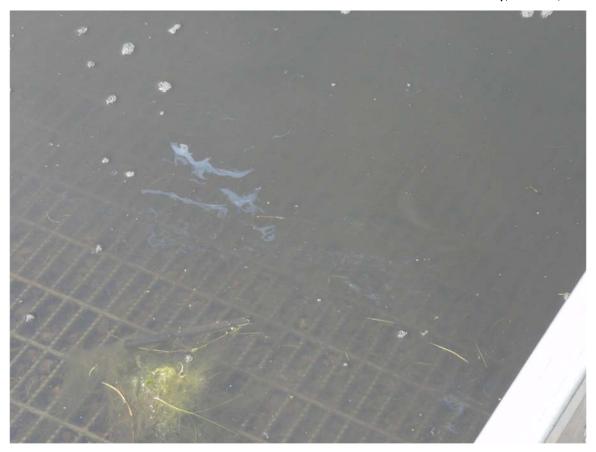
13. CO.4 Boat launch sheen observed after boat launched.

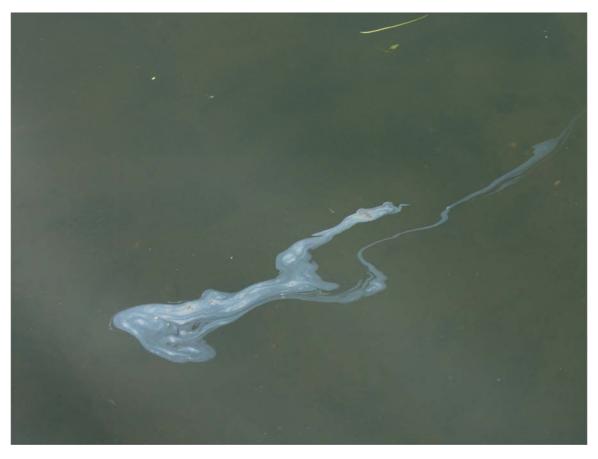
14. MP5.6 LDB sheen observed.

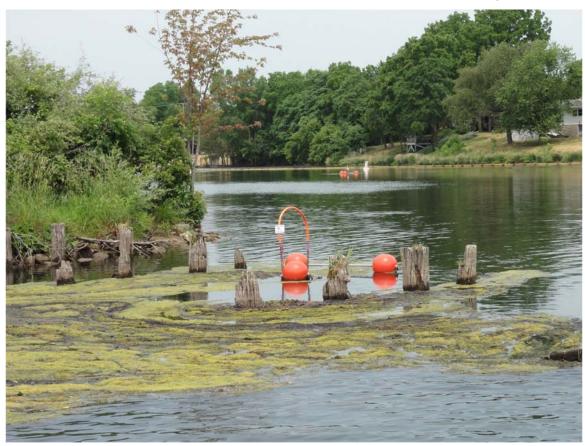
15. MP5.63 LDB vegetation accumulating.

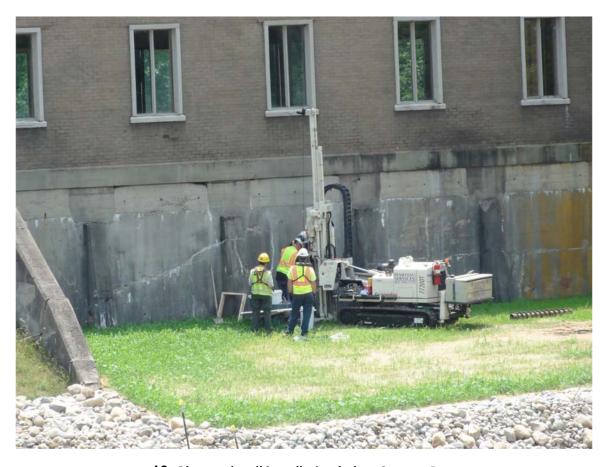
16. Observed well installation below Ceresco Dam.

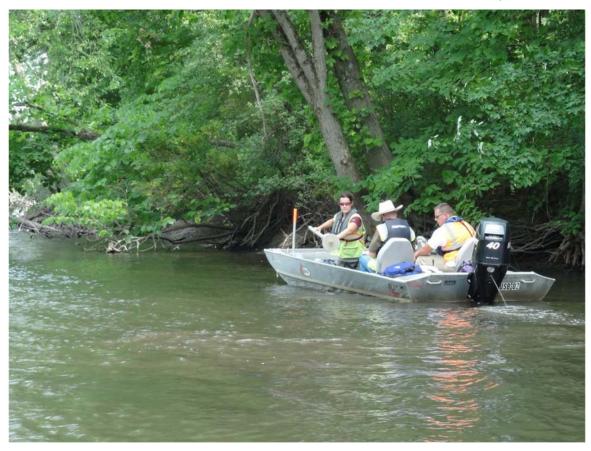
17. MP29.25 Poling crew observed.

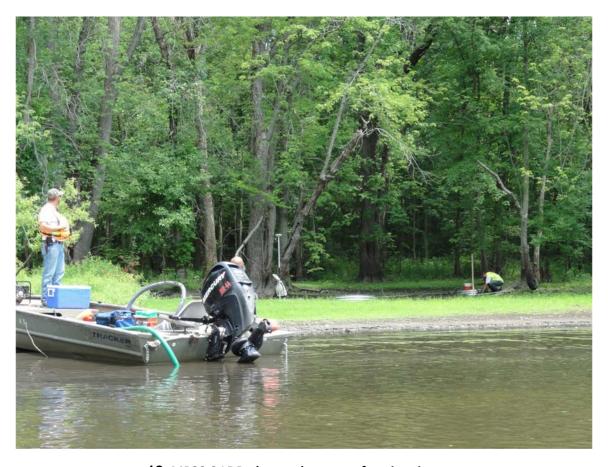
18. MP30.0 LDB observed crew performing ring test.

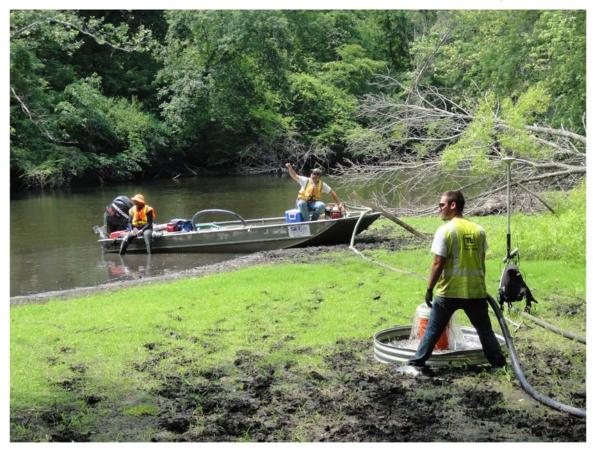
19. MP30.0 LDB observed crew performing ring test.

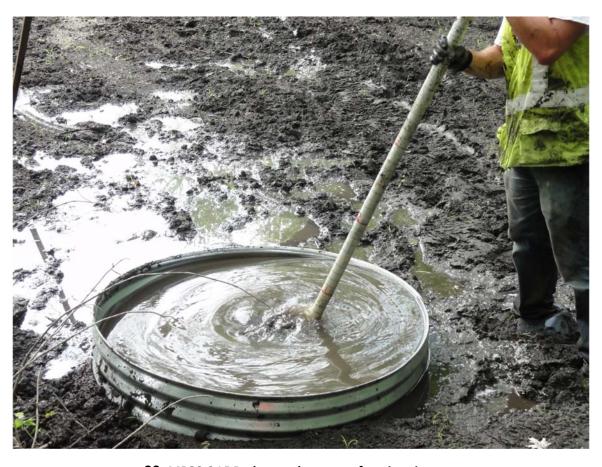
20. MP30.0 LDB observed crew performing ring test.

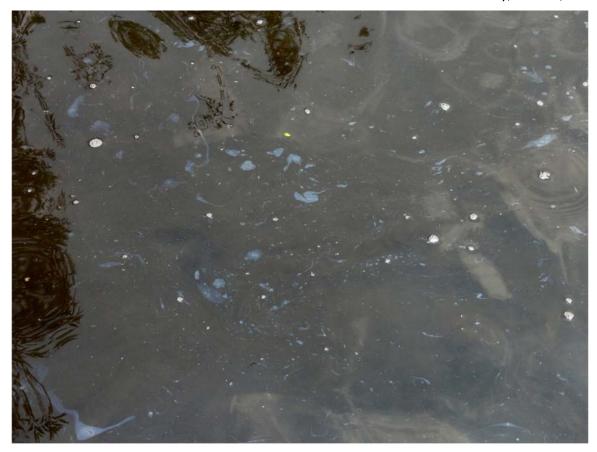
21. MP30.0 LDB sheen observed around boat when we docked.

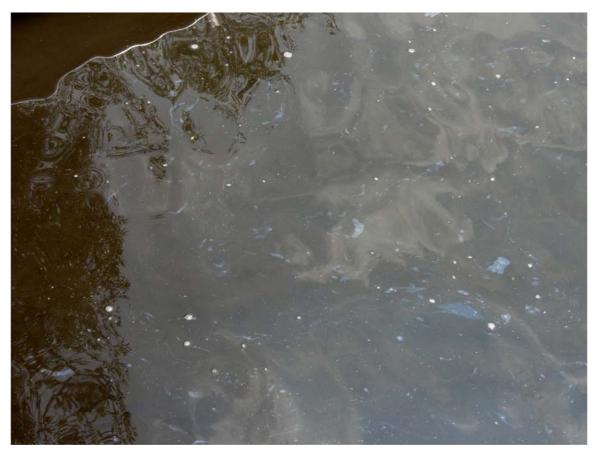
22. MP30.0 LDB sheen observed around boat when we docked.

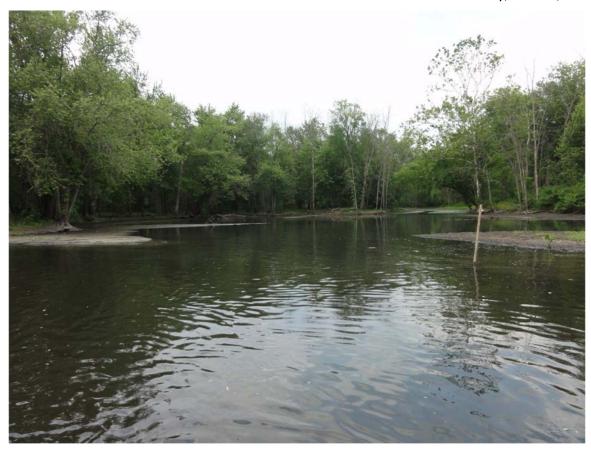
23. MP30.8 LDB sheen observed.

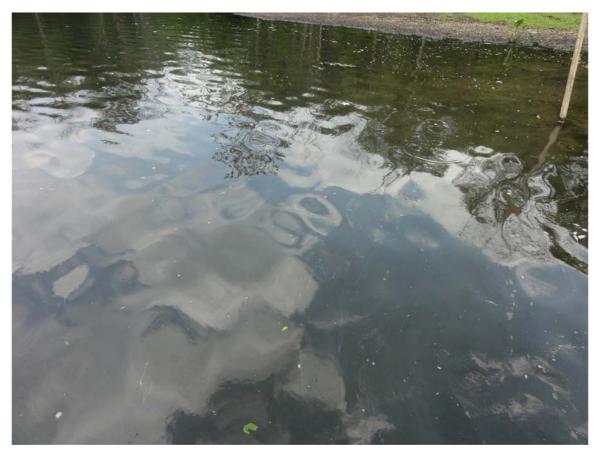
24. MP30.8 LDB sheen observed.

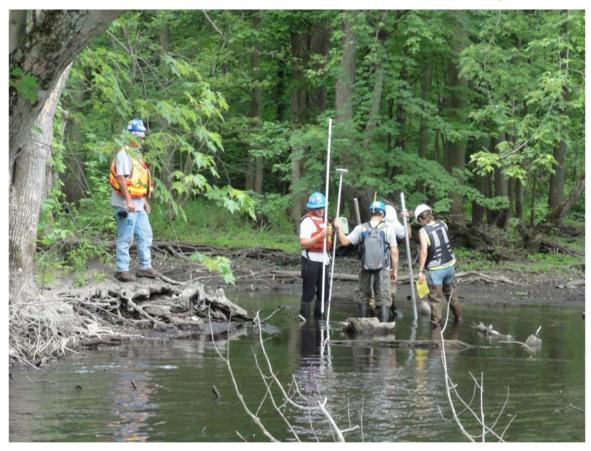
25. MP32.5 STRIKE poiling team observed.

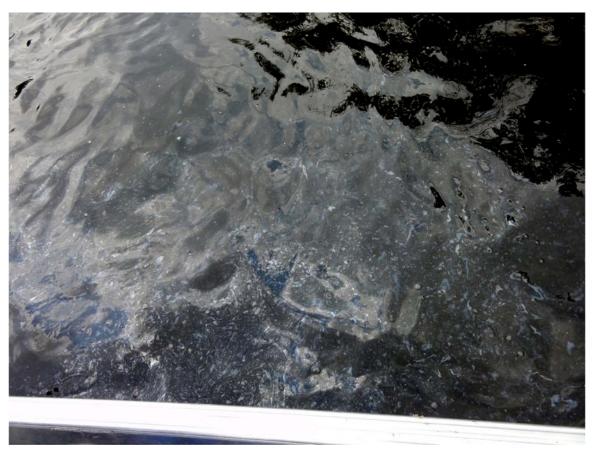
26. MP32.5 RDB sheen observed around boat when we reversed.

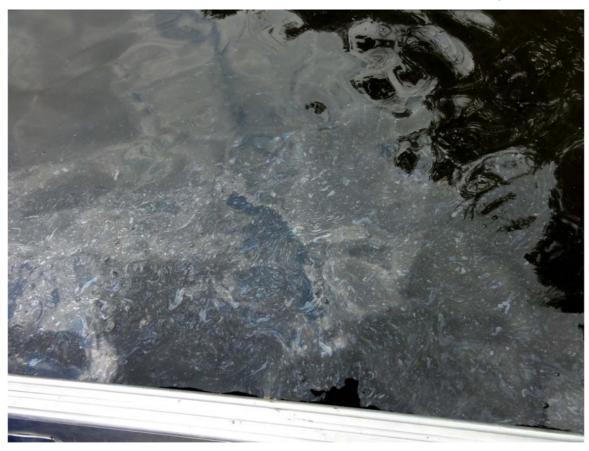
27. MP32.5 RDB sheen observed around boat when we reversed.

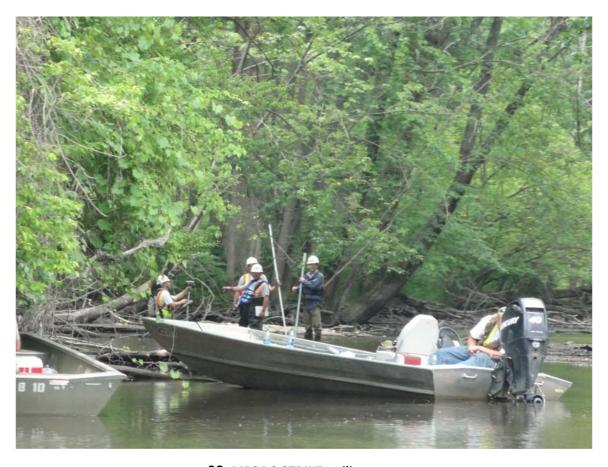
28. MP34.0 STRIKE poiling team.

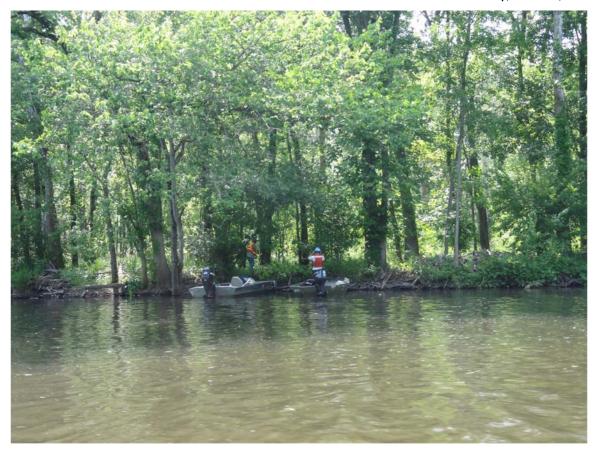
29. MP36.25 RDB overbank STRIKE team observed.

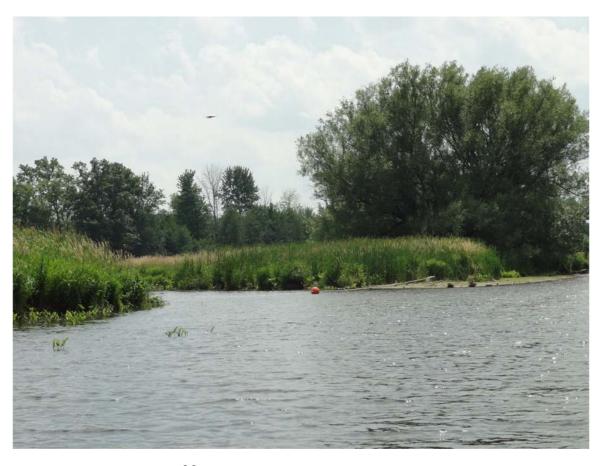
30. Morrow Lake Delta buoys deployed.

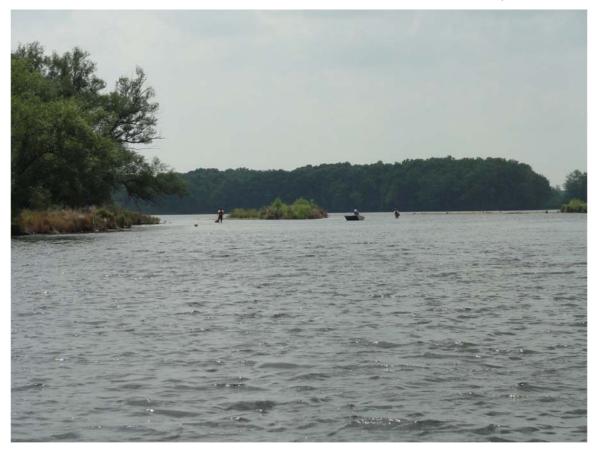
31. Morrow Lake Delta buoys being deployed.

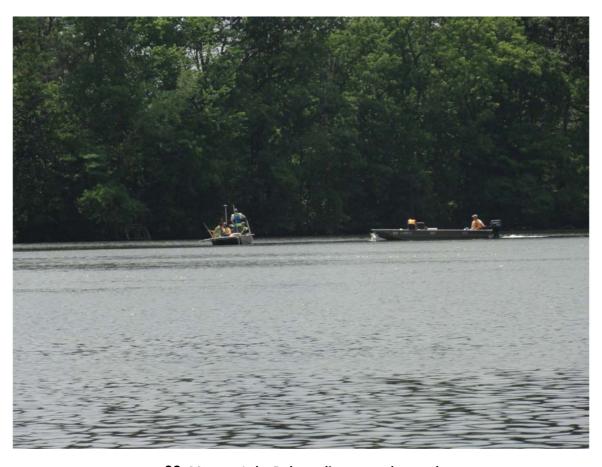
32. Morrow Lake Delta poling crew observed.

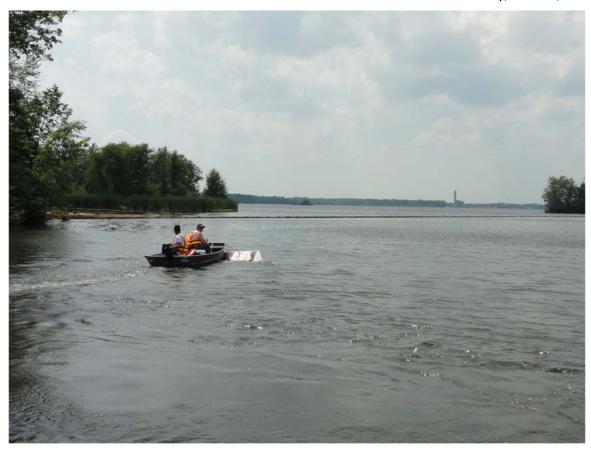
33. Morrow Lake Delta sheen sweep observed at E4 boom.

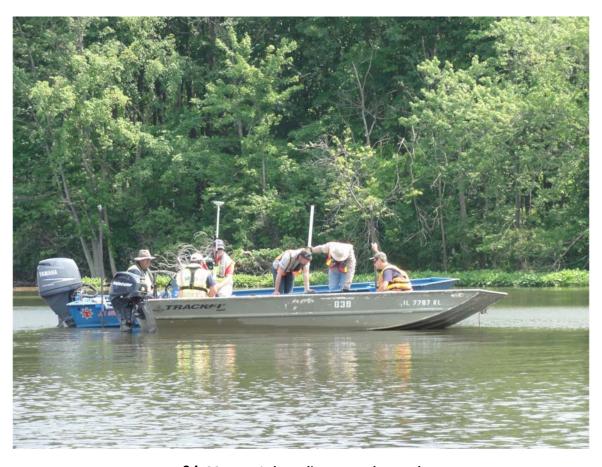
34. Morrow Lake poling crew observed.

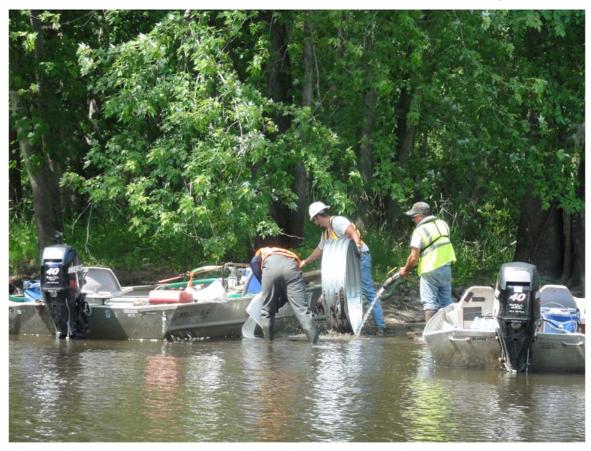
35. MP33.0 observed crew decontaminating test ring.

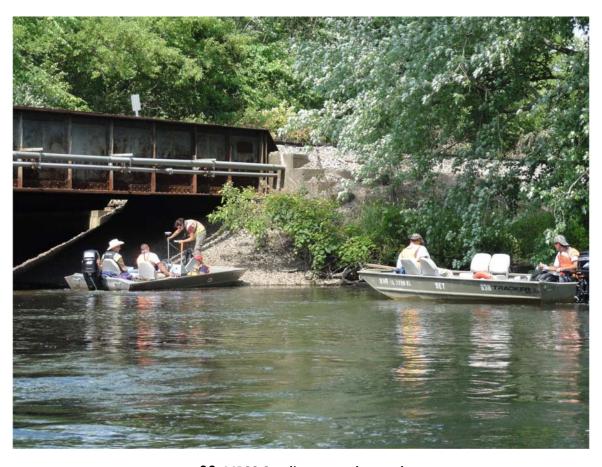
36. MP29.0 poling crew observed.
